Work Order ID 149139***149139***

Item ID: D4634-141 Accept ***N900040100*** Setup Start ***NS1***
Revision ID: Stop ***NS2***
Item Name: Fwd, Center Ceiling Replacement Panel Assembly
Start Date: 7/13/2016 Start Qty: 1.00 ***1*** Cust Item ID:
Required Date: 7/19/2016 Req'd Qty: 1.00 ***1*** Customer:
Reference:

WORK ORDER NON-CONFORMANCE / UPDATE

Work Order: 149139		DISPOSITION		AGAINST DEPARTMENT/PROCESS					
Part No. D4634-141		Rework ☐		Skid-tube ☐	Cross tube ☐	Water Jet ☐	Engineering ☐		
NCR No. 16-5994		Scrap ☐		Machining ☐	Small Fab ☒	Prod. Eng. Coord. ☐	Quality ☐		
		Use-as-is ☐		Thermoforming ☐	Finishing ☐	Rec/Store/Packaging ☐	Other ☐		
		Suspected Unapproved ☐		Large Fab ☐	Composite ☐	Supplier ☐			
Date: 16-08-22		Step #: 110		QTY Effective: ①			MRB (QSI042) Approval		
Description Work Order Deviation				Disposition			Completed By		
WHILE INSTALLING MS20426AD 3-6 RIVETS THE RIVETS WOULD NOT INSTALL WITH OUT DAMAGING LEXAN MATERIAL CR 16-153				REMOVE MS20426AD 3-6 RIVETS AND INSTALL CCR26455-3-03 RIVETS (M135127) (4) QTY see attach Email.			AUG 22 2016 DAS 27 9-89 16-08-22		
							Lead hand / Supervisor Approval Verification		
							QC / QA Coordinator Approval

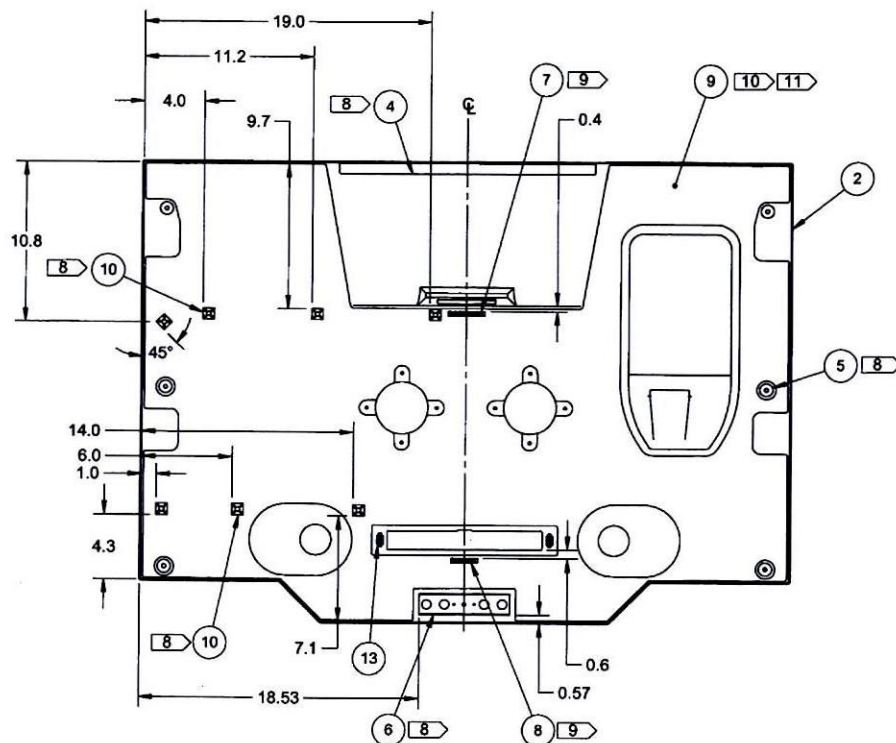
Misidentified ☐	Past Due ☐	OTHER: rivets.

On the part which was brought to my concern there was superficial damage when he removed the rivet.

I saw the problems he was having and suggested to replace the rivets as a production tweek. I assessed the situation and suggested using an Anchor Nut Rivet (CCR264SS-3-03) when replacing the unacceptable rivet he showed me.

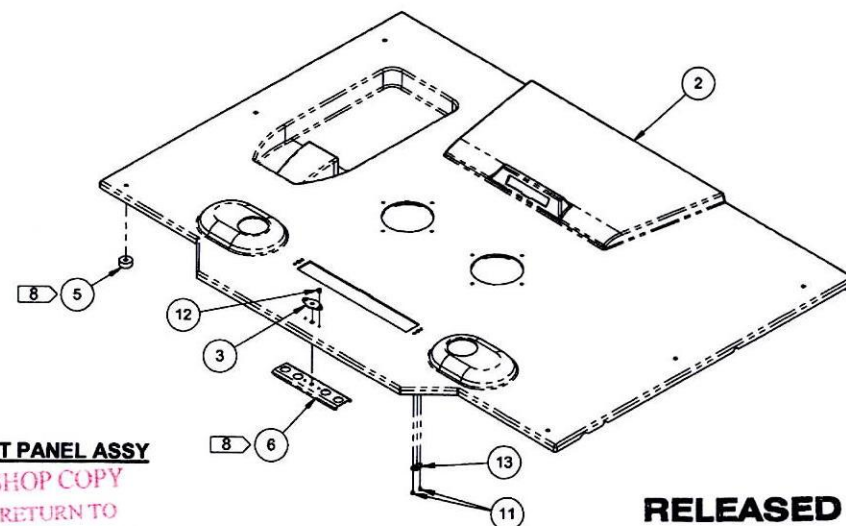
They are assembling D4634-14X Ceiling Panels on the floor. To mount the Light, we have two nutplates riveted to the ceiling panel using MS20426AD3-4 solid rivets (eg. Sheet 7, Item 10). They are installing these nutplates using a hand bucking tool and have asked if this could be changed to a countersunk POP rivet to simplify the assembly?
